# Failure Analysis of the HCL Column InterCooler Cause, Effect, Results and Economical Solution for Severe Media Case Study

By ENG. MOHSEN ZAHER - DESIGN SECTOR MANAGER (EPC)

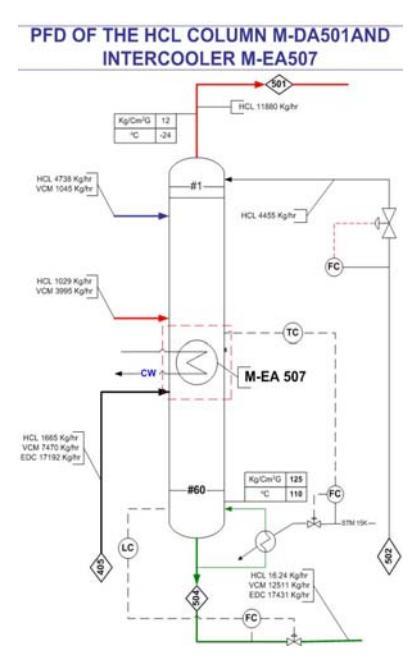
M-DA 501 HCL Column

The main problem has correlation with section 500 of the VCM plant (purification section), it is limited by the HCL column M-DA 501, the intercooler M-EA 507 and the interconnected circuits as shown in the PFD (Process Flow Diagram).

The intercooler **M-EA507** is embedded in the **HCL** column at it's mid of Elevation, The intercooler **M-EA507** helps to maintain, Control and keep the thermal balancing of the operating condition; obviously it plays an important role to control the performance of **M-DA 501**.

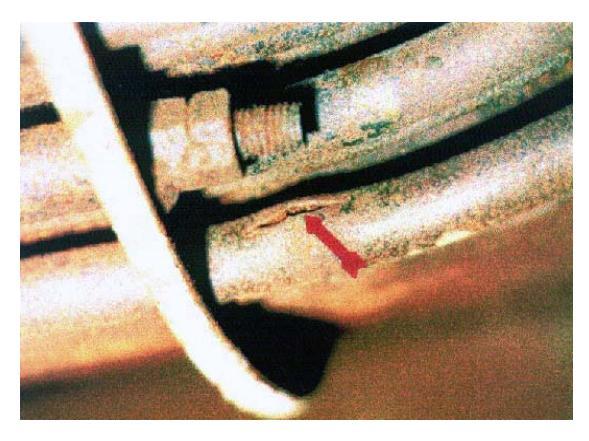
3-Longitudinal crack at the tube bend.

M-EA507Longitudinal Cracking at one of the tubes

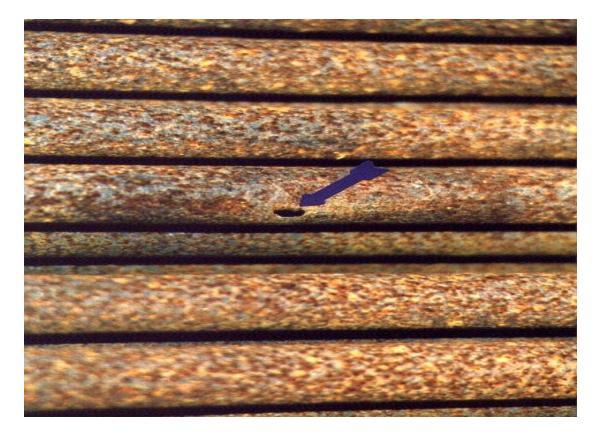
Acidic areas on a metal surface remains stationary rather than shift about .When this occurs corrosion takes the form of pits rather than general thinning (uniform Corrosion).Although pitting can arise from various causes , chlorides are well known as pit producers.

The chloride IONS accumulate at ANODIC areas and either penetrate or dissolve the passive film.Since the chloride corrosion product is **HYDROLYZED to HYROCHLORIC Acid**, The acidity at the ANODE increases as more Chloride migrates to the ANODE and the corrosion rate increases with time .Self accelerating reactions of this kind are described **AUTOCATALYTIC** reaction.

1-Pitting at different locations on the tube surface.

Localized Corrosion and pitting

# a) To use a higher grade of material to overcome the corrosion problems at the upset conditions.

The selected NEW material to fulfill both technical and economical requirements is Super Duplex Stainless Steel

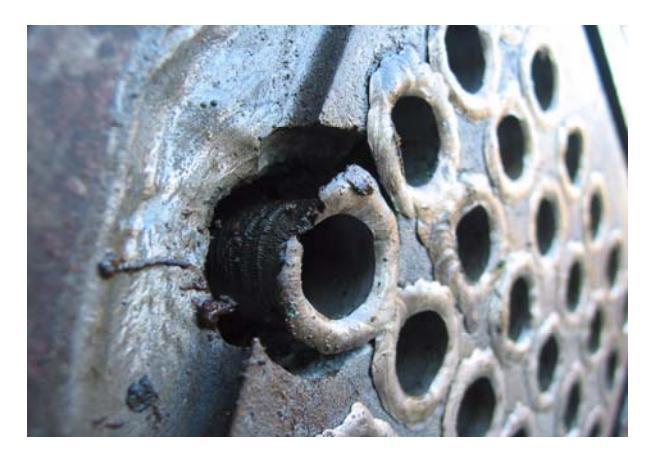
2-Failure of the seal welding of the tube to tubesheet.

Failure for the seal welding of the tube to tubesheet

It has been observed in some cases that the problem is coming from the failure of the joining of the tube-to-tube sheet.

To overcome this problem we have changed the technique of joining the tube-totube sheet.

Since the Intercooler is operating at high pressure (at shell side) and it has been exposed to aggressive fluid ,we changed the Joining Technique to be Strength Welding instead of one pass seal welding as per Sketch(2).

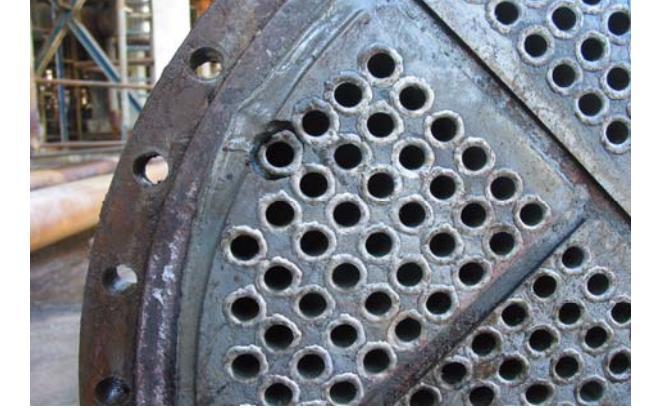
M-EA507 Tubesheet Layout – shows the location of the failed tube to tube sheet.

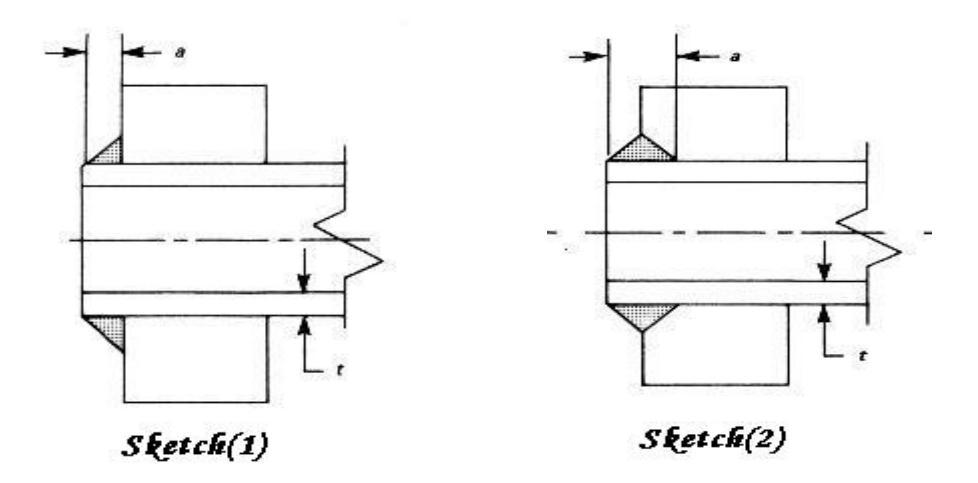
The old technique was based on seal welding of the tube-to-tube sheet (one pass) and light expansion as per Sketch (1).

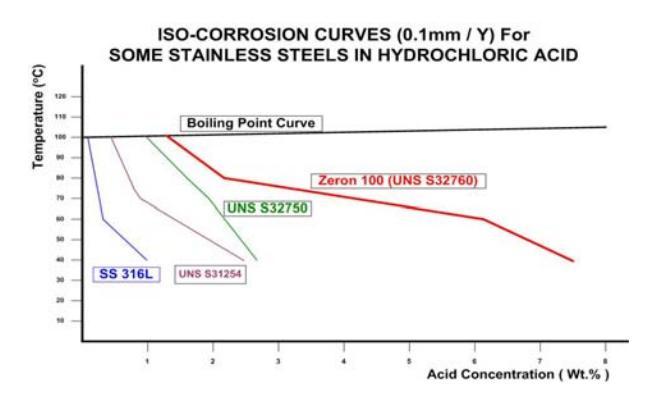
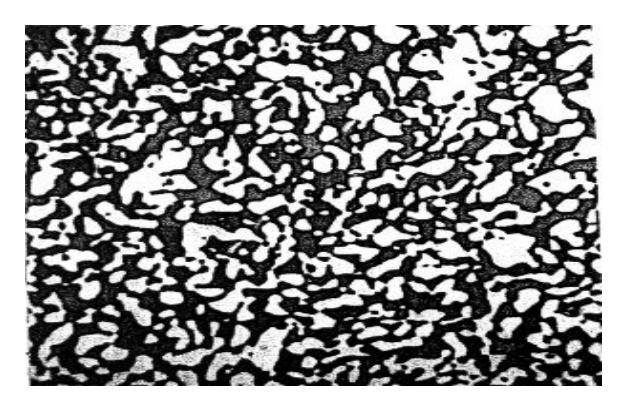
The sample reveals a regular Austenitic Ferritic structure (500 X) FREE from Carbide precipitates and Phases like SIGMA, CHI, LAVES. Micrographic test 500 magnification transverse direction Ferrite determination according to ASTM E 562 = 49.06%

(Micrographic test 500 Magnification) Super Duplex Structure 50 Ferrite and 50 Austenite
